**KEL,SET (Reay) Creek – Victoria International Airport  
North Saanich, BC**

**Confirmation of Remediation  
Public Services and Procurement Canada  
(on behalf of Transport Canada)**

**March 2020  
SLR Project No.: 205.03892.00005**

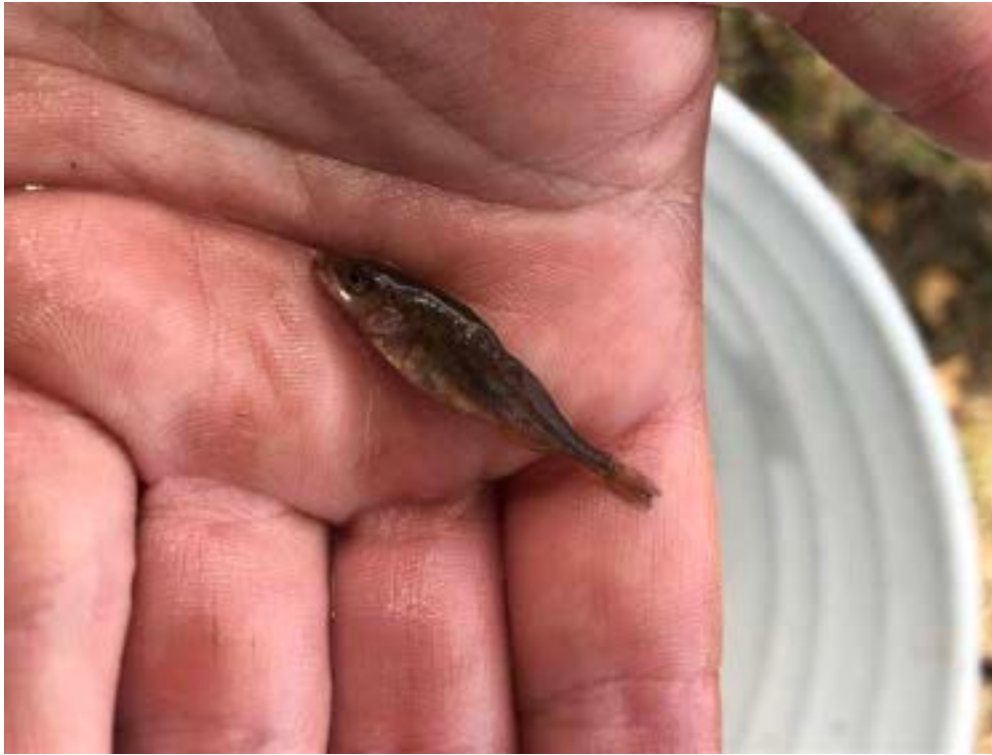
Site conditions and limitations of standardized techniques caused difficulty in capturing small (<30 mm) threespine stickleback (Photo 7) during the preconstruction fish salvage. Fish salvage techniques are known to have a limited effectiveness on very small fish. There was also high

**Photo 7:** Threespine stickleback (<30mm) captured during construction phase fish salvage.

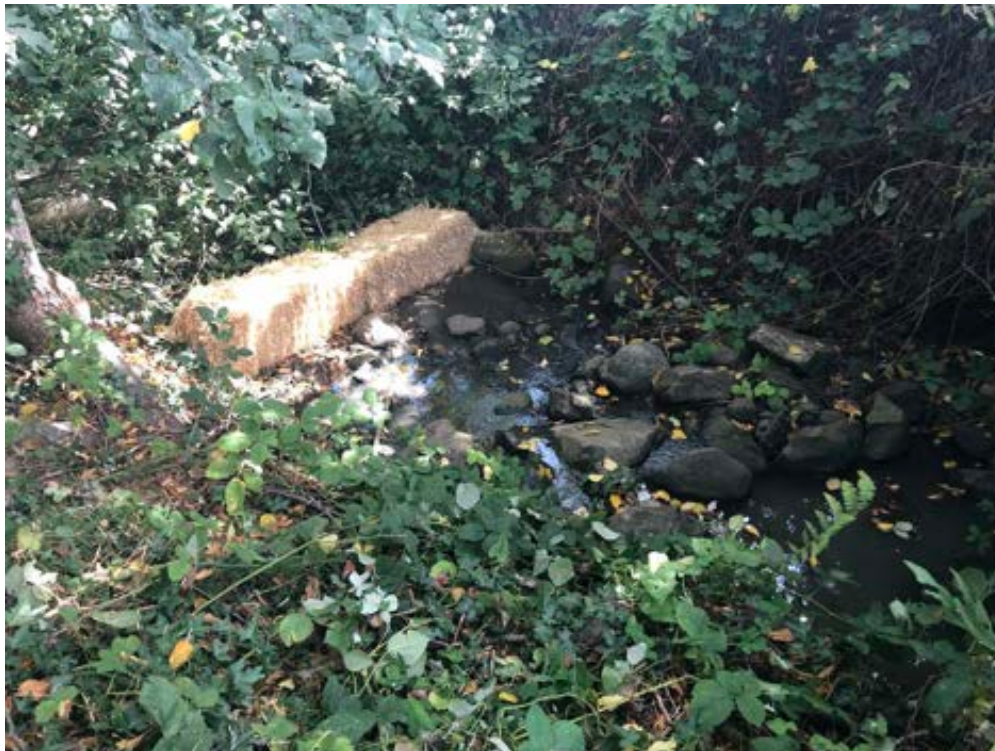
**Photo 10:** Haybales set up in Reach 1C channel as sedimentation and erosion control.

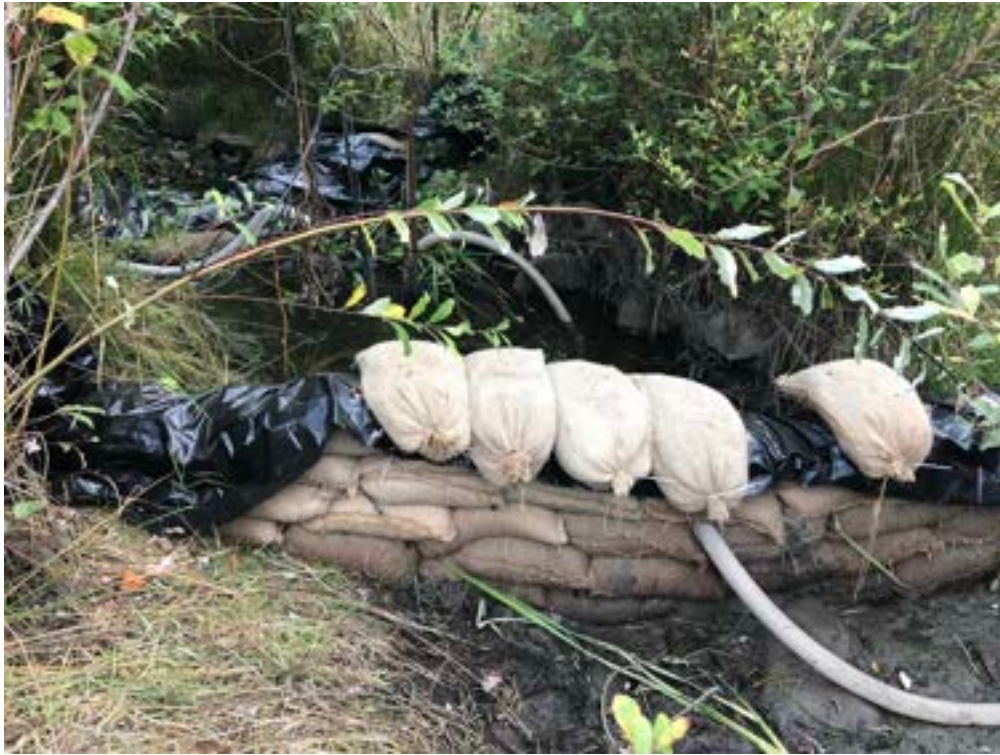
**Photo 11:** Constructed dam upstream of the remedial extent in Reach 1B.

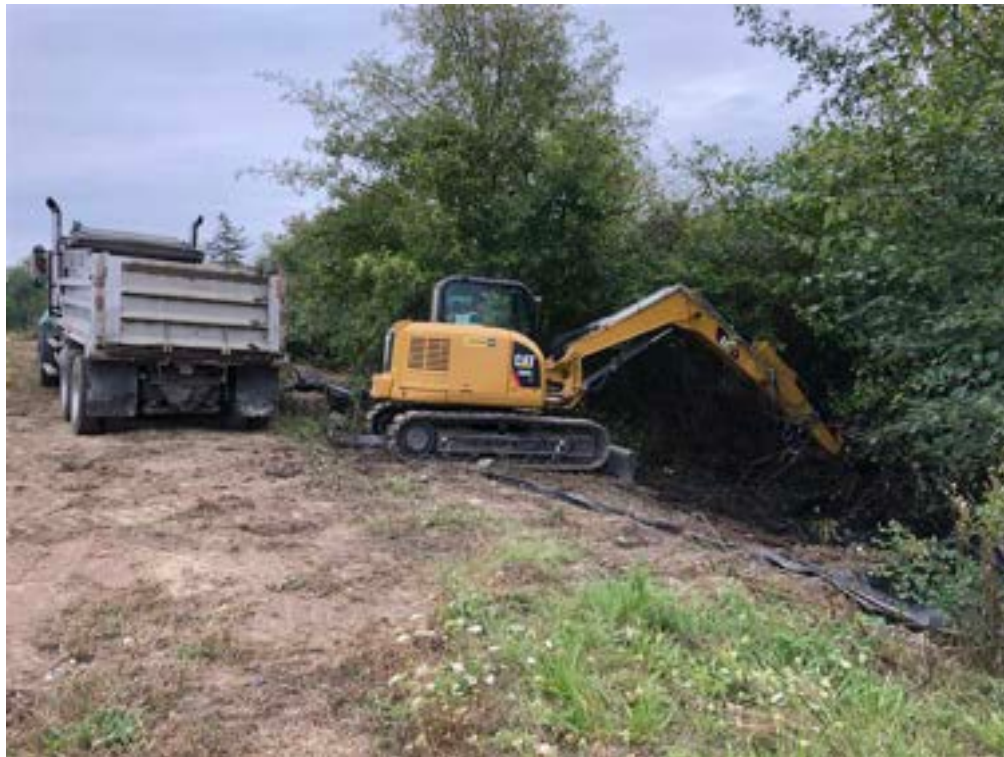
**Photo 13:** View of remedial excavation in Reach 1A, looking east. Excavated sediment was placed in dump truck and transported to the stockpile area.

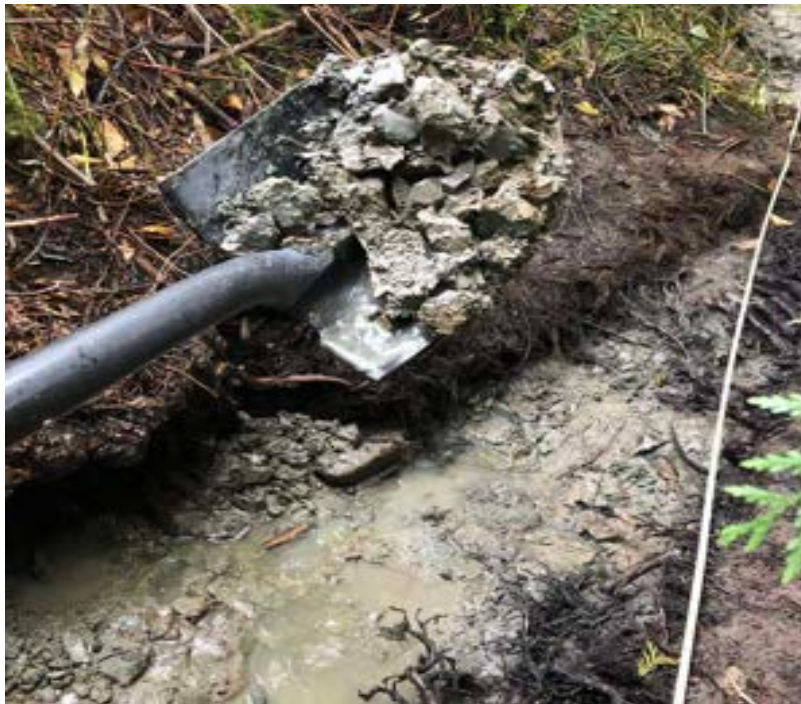
**Photo 15:** SLR collecting confirmatory samples following hydrovac excavation in Reach 3.

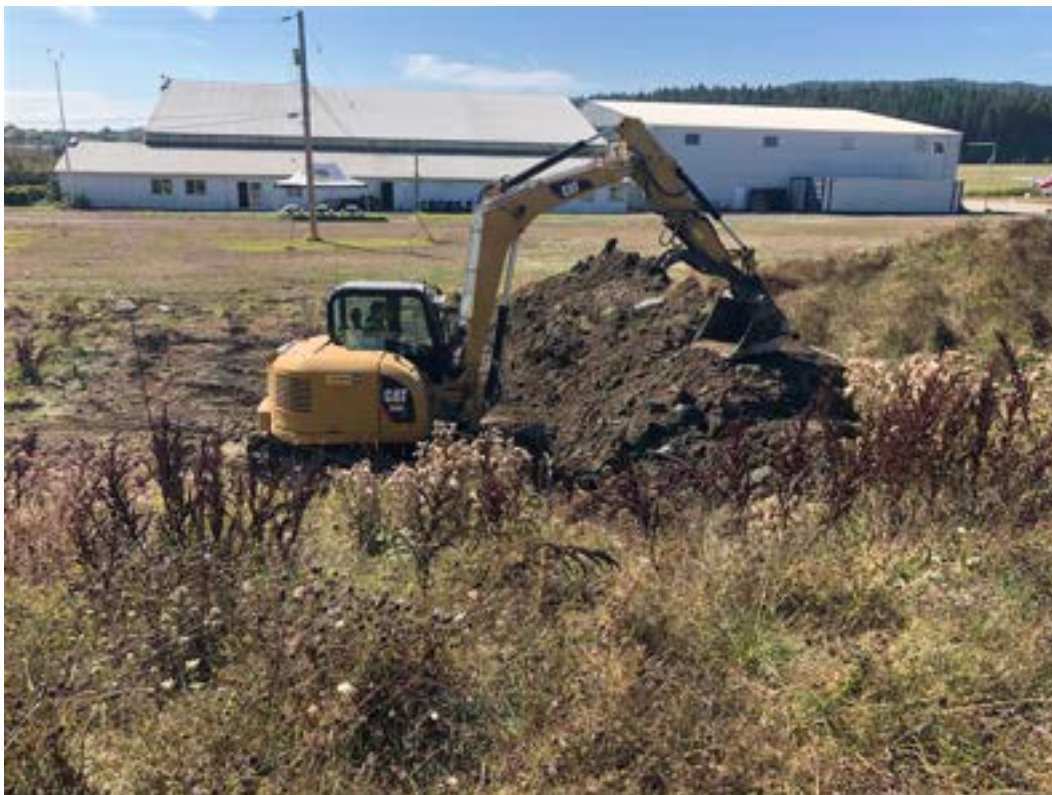
**Photo 16:** View looking south at Contractor using existing stockpiles to create berm for containment cell in the stockpile management area. Berms were covered with polyethylene liner to segregate from other stockpiled material.

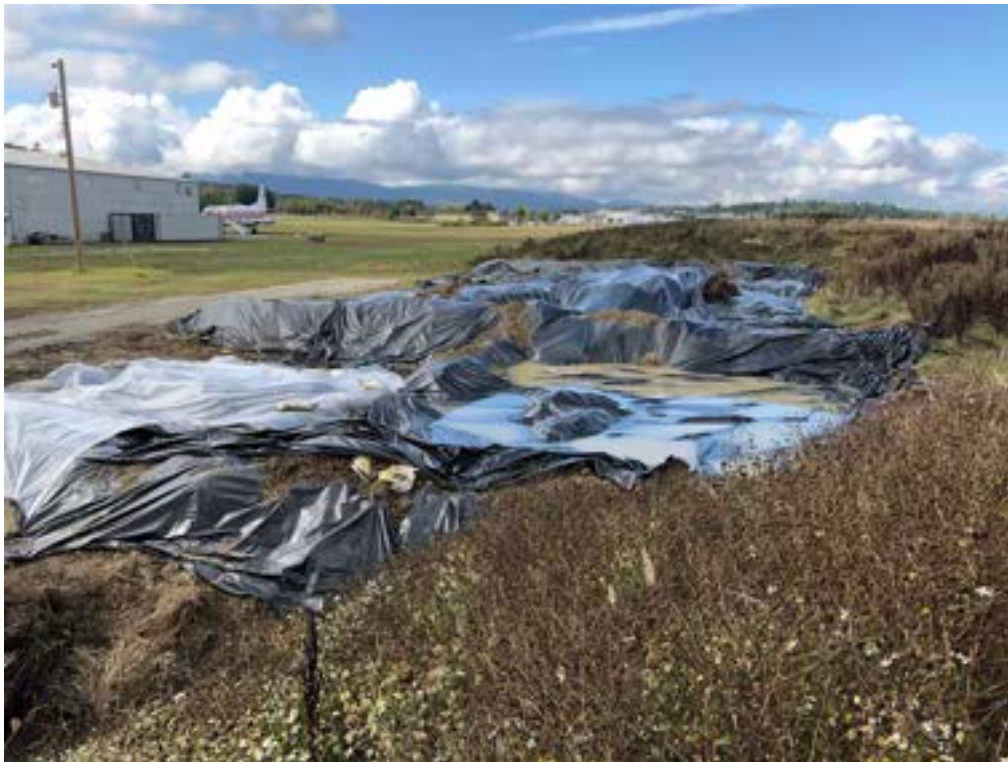
**Photo 17:** View of excavated sediment in containment cells lined and covered with polyethylene liner, looking west.

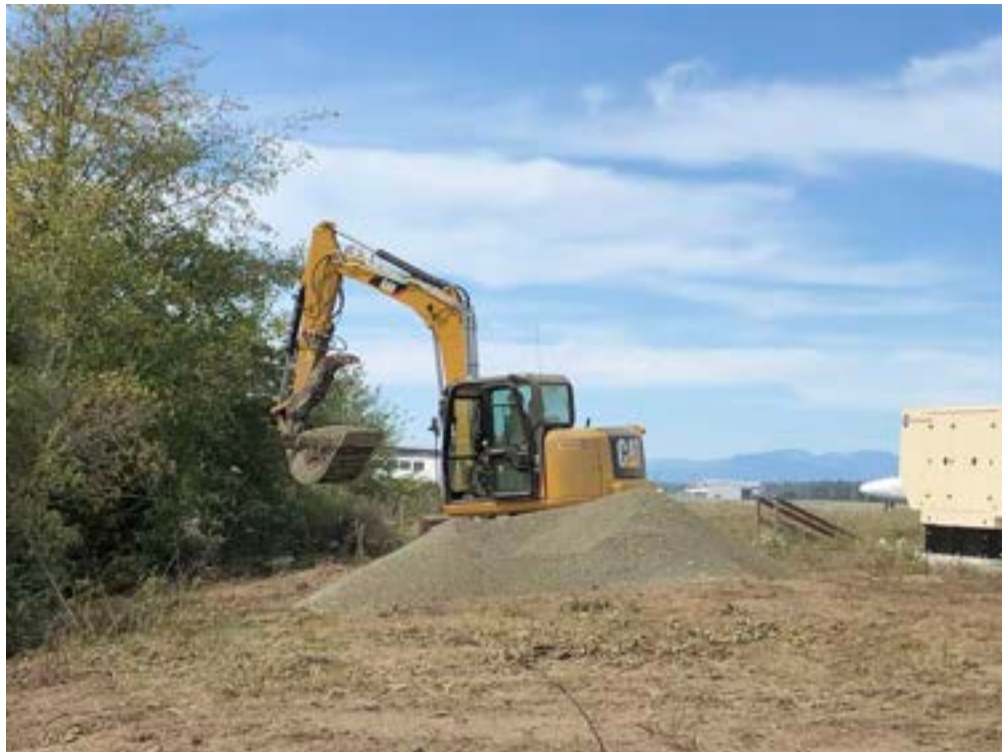
Multiple methods for backfill placement were used in different areas. In Reach 1A, Reach 1B and upper Reach 1C, an excavator was used to place backfill (Photo 20); in lower Reach 1C, Reach 3 and Reach 4 where access was limited, a slinger truck was used to place backfill (Photo 21). In all reaches, backfill was raked by hand to final conditions. Final backfill conditions in each reach are shown in Drawings 4A and 4B. A summary of backfill placed within each reach is shown in Table E below.

**Photo 20:** View of Contractor placing Type 1 backfill material in Reach 1A with an excavator.

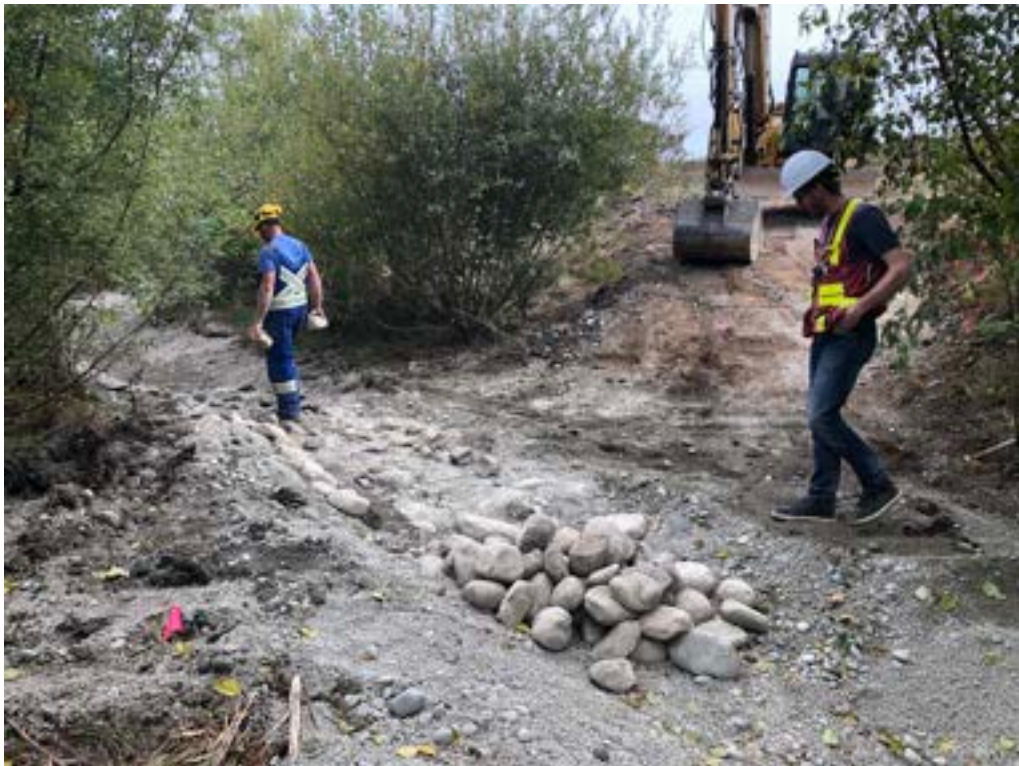
Additionally, during excavation in Reach 1B, the upstream and downstream slopes of riffles 3 and 4 (Drawing 2) were damaged by the Contractor. The riffles provided flow diversity within the channel of Reach 1B and therefore required reinstatement. Through field observations by SLR and KWL staff, it was determined that the body of the riffles and riffle crests remained in place. Repairs were made to the slopes of both riffles by the Contractor under direction from KWL (Photos 22 - 23). The document prepared by KWL including recommendations for riffle slope reinstatement is attached in Appendix A. Record drawings are included in Appendix K.

**Photo 22:** View of KWL personnel inspecting Contractor repairs to riffle 3 within Reach 1B.

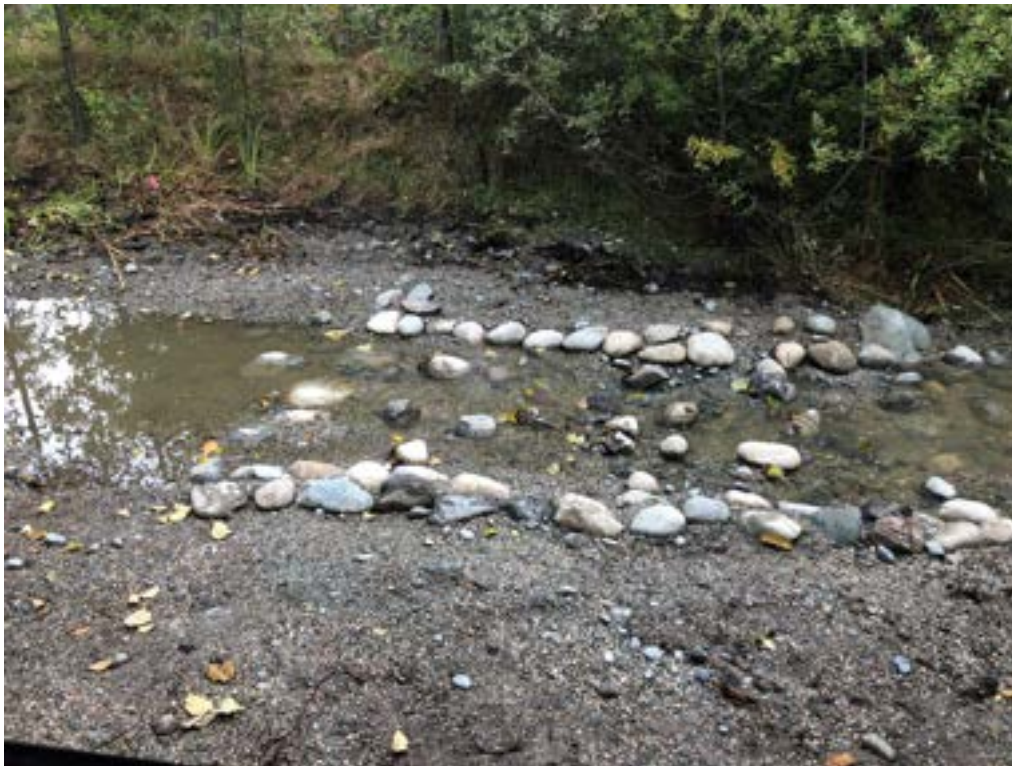
**Photo 23:** Riffle 3 in Reach 1B after riffle repair and backfill complete.

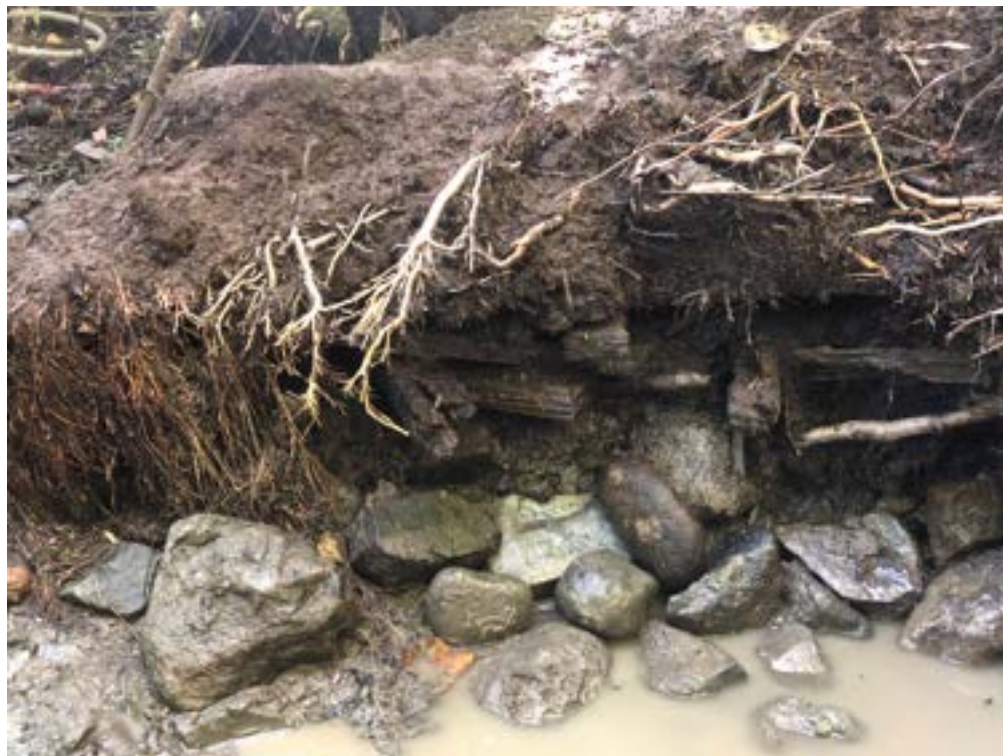
The downstream extent of Reach 4 was additionally excavated by 0.4 m on the west wall to address contamination in an initial confirmatory sample. The analytical results for the additional confirmatory sample were below the BC CSR SedFS standards for all parameters analyzed. However, there was visual hydrocarbon staining, strong odour and wood debris along the west wall; therefore, additional investigation may be warranted and is recommended.

- However, during the additional wall excavation, there was visual hydrocarbon staining, strong odour and wood debris in select locations along the west wall of the creek (Photo 24). Analytical results were below the BC CSR SedFS standards for all parameters analyzed (including hydrocarbon parameters).

**Photo 24:** View of remaining wood debris after additional excavation in Reach 4.

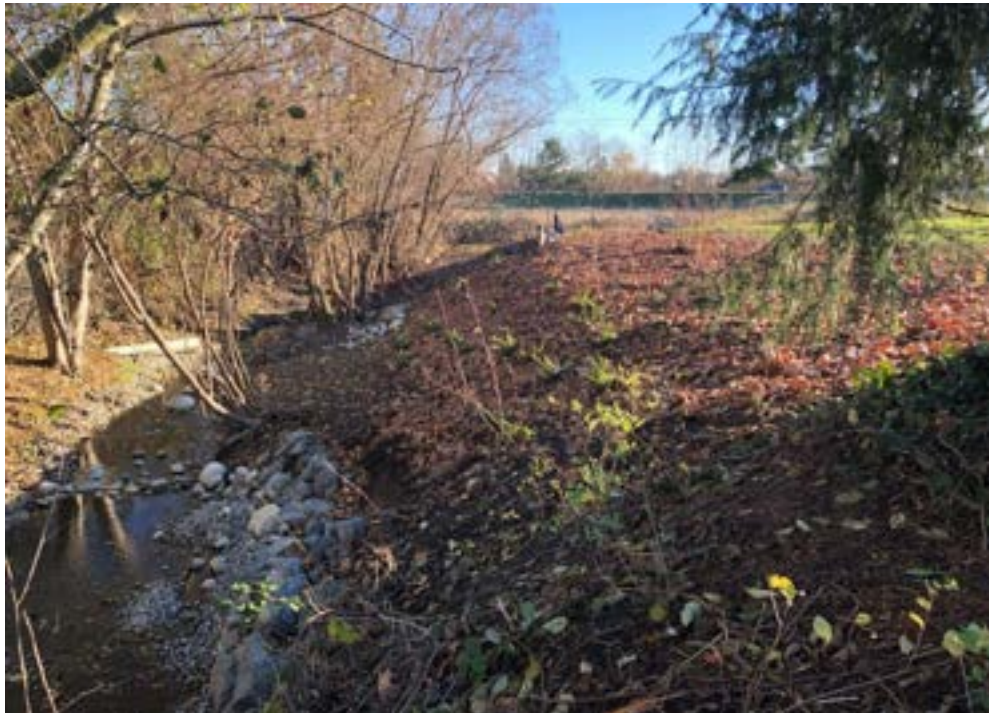
SLR noted that some additional work had been completed in Reach 1C during the gap between the construction phase of the Project and the site restoration phase. A retaining wall had been constructed to stabilize the steep slope on the downstream side of the culvert that runs under the access road (Photo 26). This work was completed through the VAA and is not related to the remedial works conducted under the TC/PSPC contract.

**Photo 26:** View looking downstream (east) along lower Reach 1C. Western sword fern plantings with leaf mulch can be seen along the stream edge and bank. VAA installed retaining wall can also be seen on the lower left.

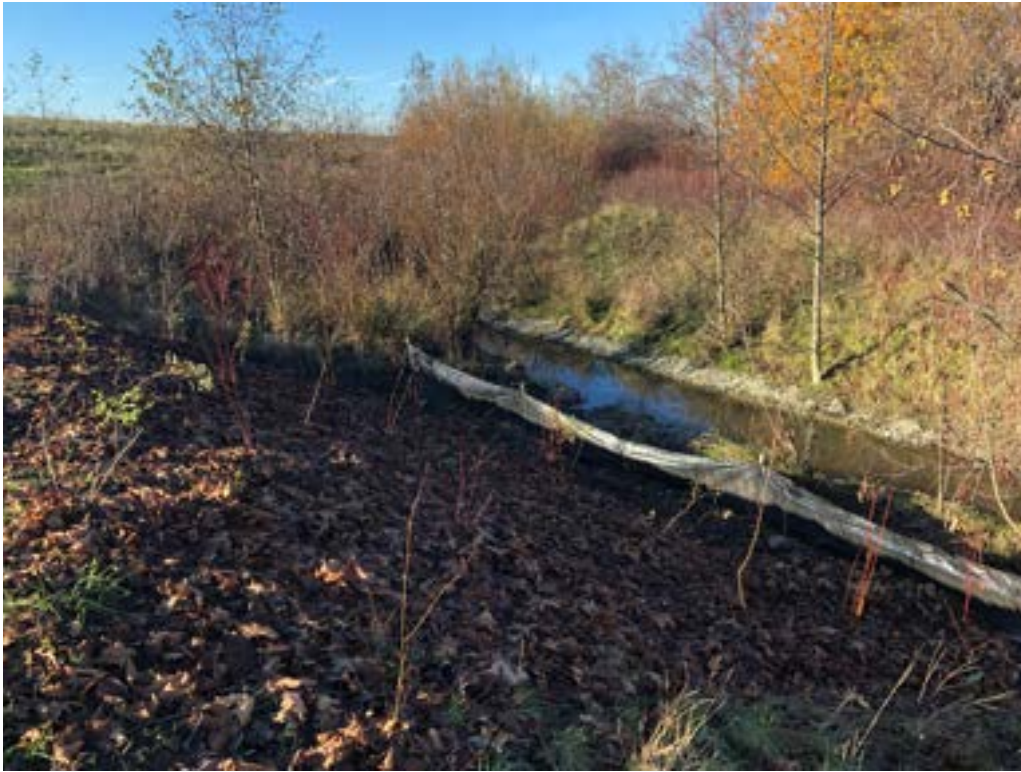
Reach 1B: Planting occurred in select areas where vegetation removal was required for access (Photo 29). WES selected trembling aspen as a first choice for planting in these areas and indicated their installation would depend on availability. A wider variety of plant species from the list above was observed to be planted along Reach 1B than was originally indicated in the Restoration Plan. SLR observed planted red osier dogwood, common snowberry, pacific ninebark, black hawthorn, and other unidentified nursery plants along Reach 1B.

**Photo 29:** View looking west at an access location along the south side of Reach 1B (west of the large oak tree), riparian planting complete.
