**KEL,SET (Reay) Creek – Victoria International Airport  
North Saanich, BC**

**Confirmation of Remediation  
Public Services and Procurement Canada  
(on behalf of Transport Canada)**

**March 2020  
SLR Project No.: 205.03892.00005**

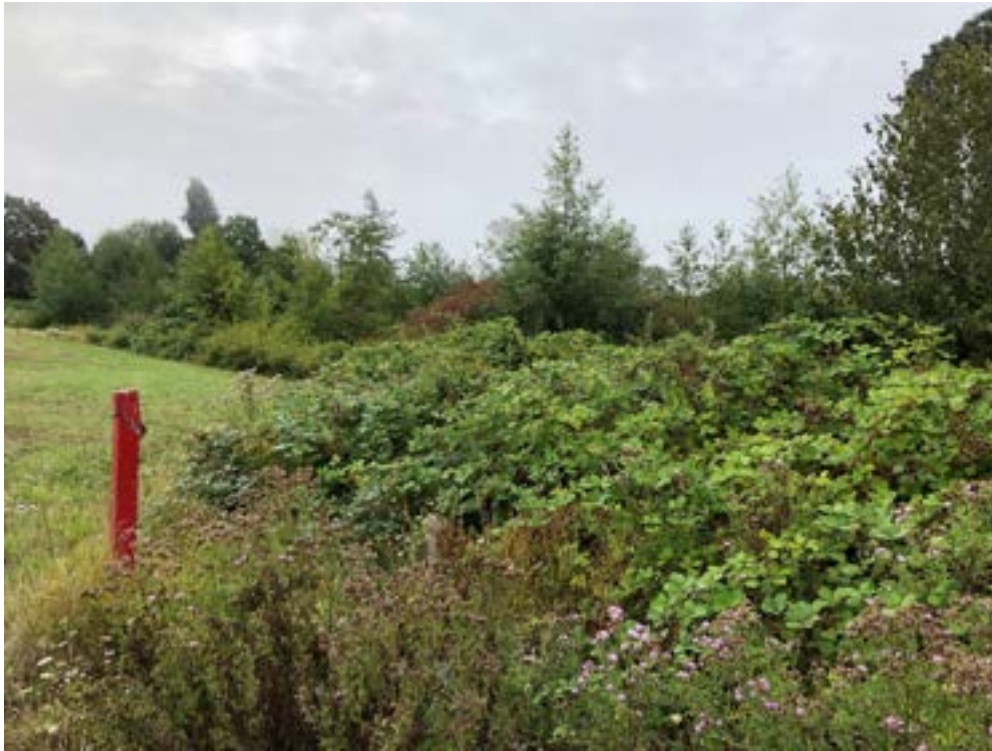
**Photo 1:** A large patch of Himalayan blackberry prior to removal on the north side of Reach 1A, looking east.

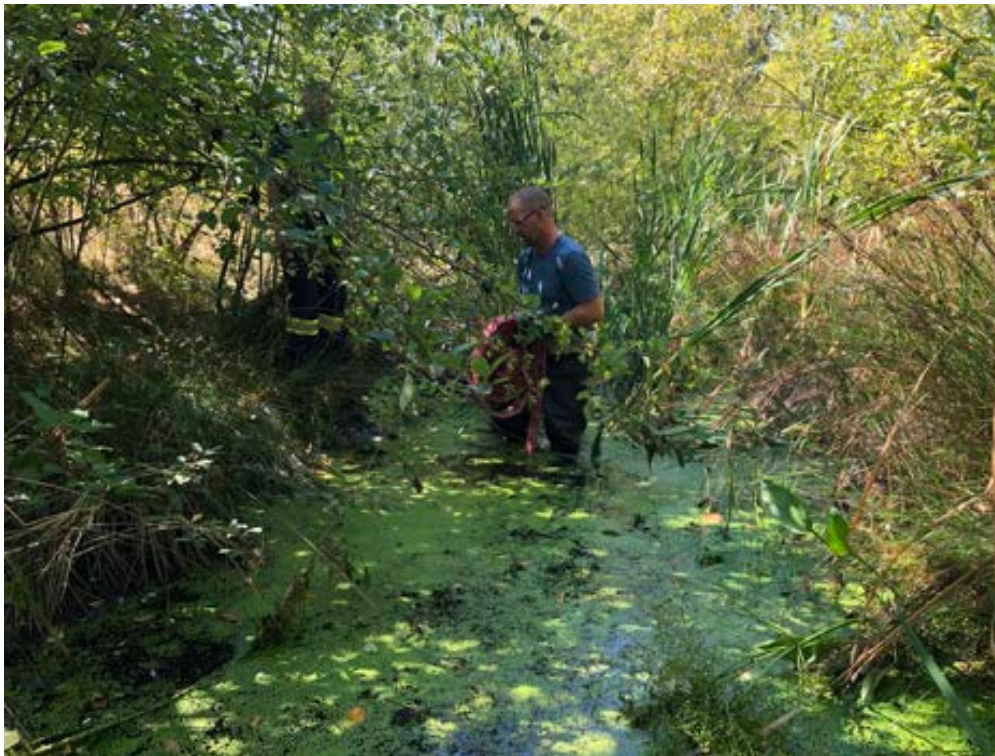
**Photo 2:** View of the Contractor running hoses during dewatering phase in Reach 1B. Instream vegetation in Reach 1B consisted primarily of duckweed and common cattail.

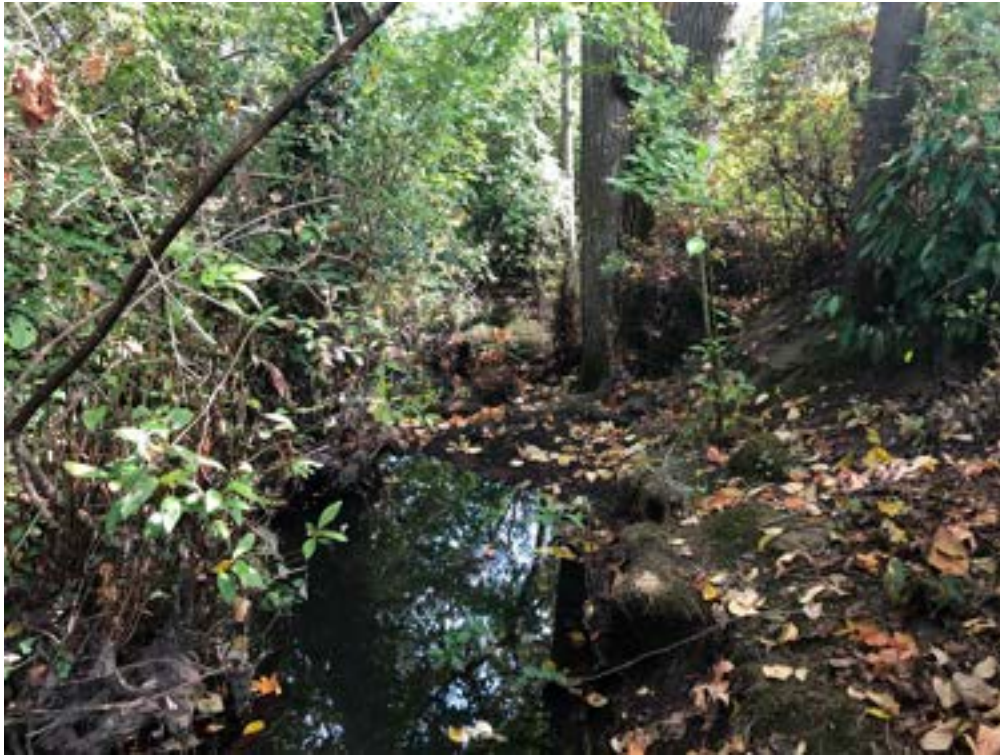
**Photo 3:** View looking downstream along Reach 4 prior to excavation. Larger trees and shrubs can be seen in the riparian area.

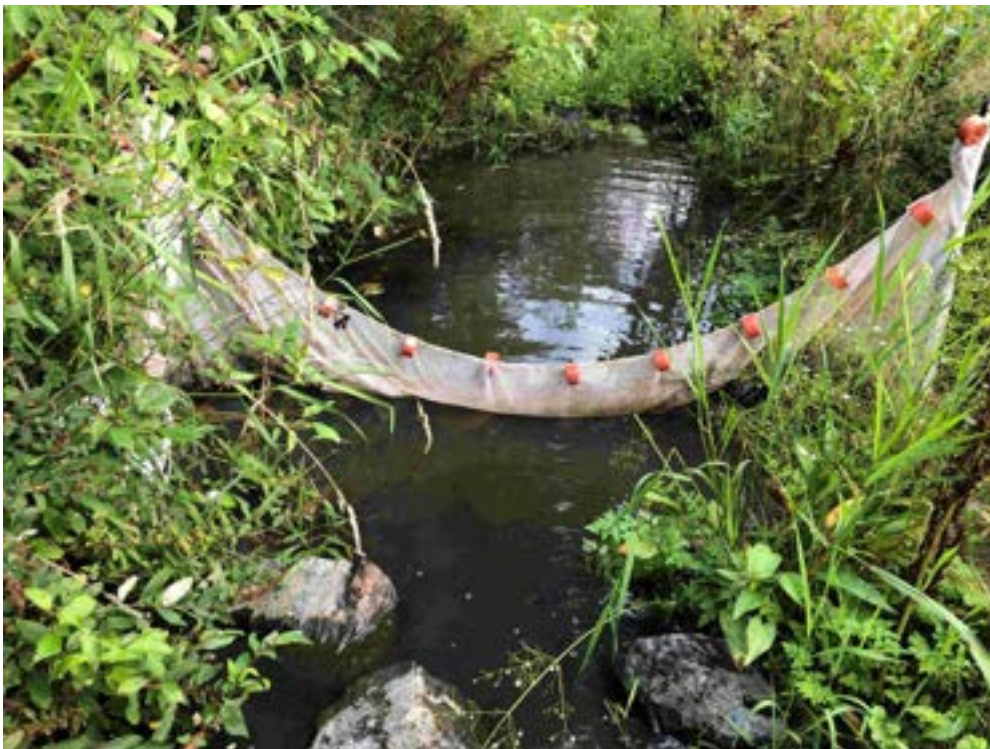
**Photo 4:** View looking east at the fish stop net installed downstream of Reach 1C excavation limit.

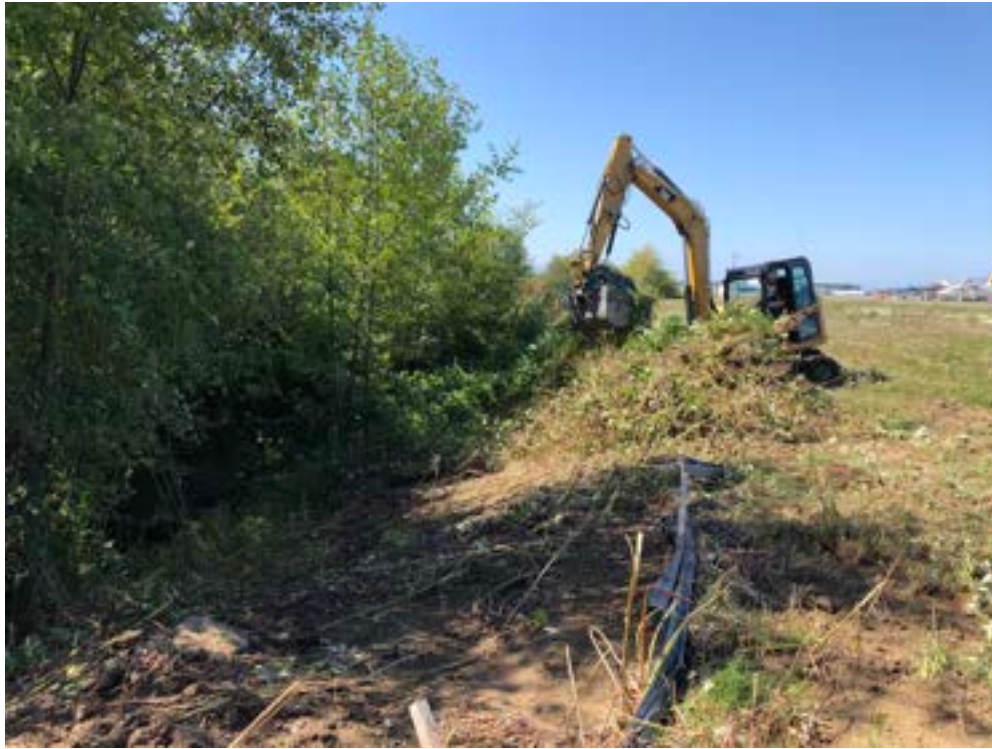
Between August 27 and August 31, 2019, Tervita cleared the Site of invasive Himalayan blackberry using an excavator in Reach 1A and Reach 1C (Photo 9). The cleared blackberry was loaded into steel bins for off-site disposal at Metchosin Properties' Goldstream Heights Fill Site Facility, Langford, BC. Invasive plant removal was overseen by the Environmental Monitors.

**Photo 9:** Himalayan blackberry removal on the north side of Reach 1C, looking west.

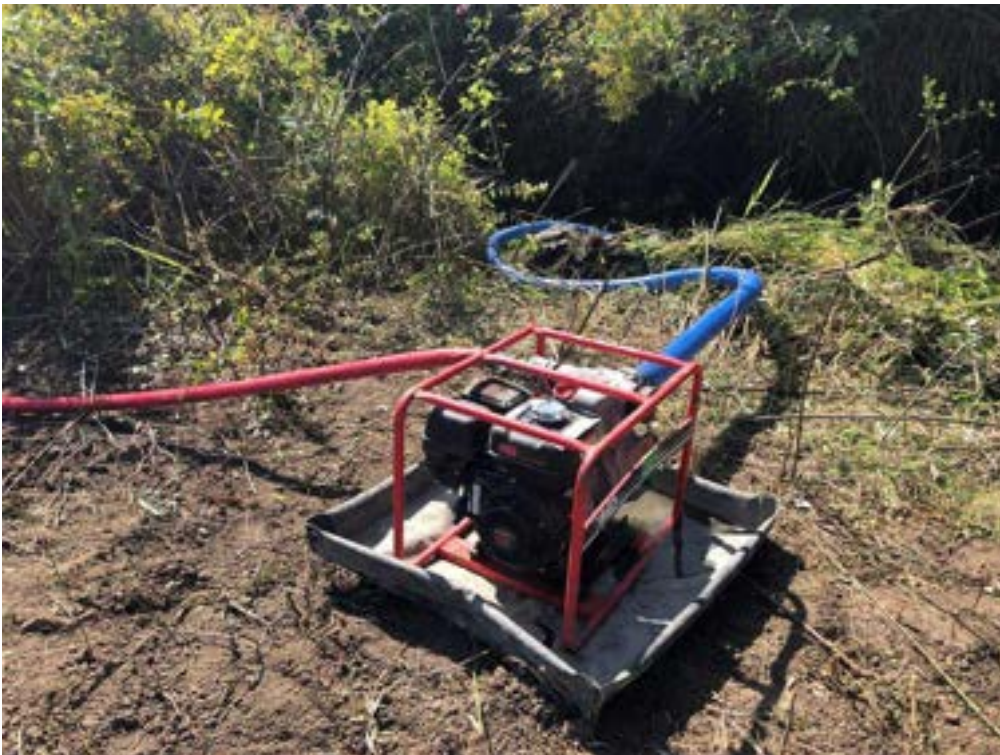
**Photo 12:** Dewatering equipment set up on the north side of Reach 1A.

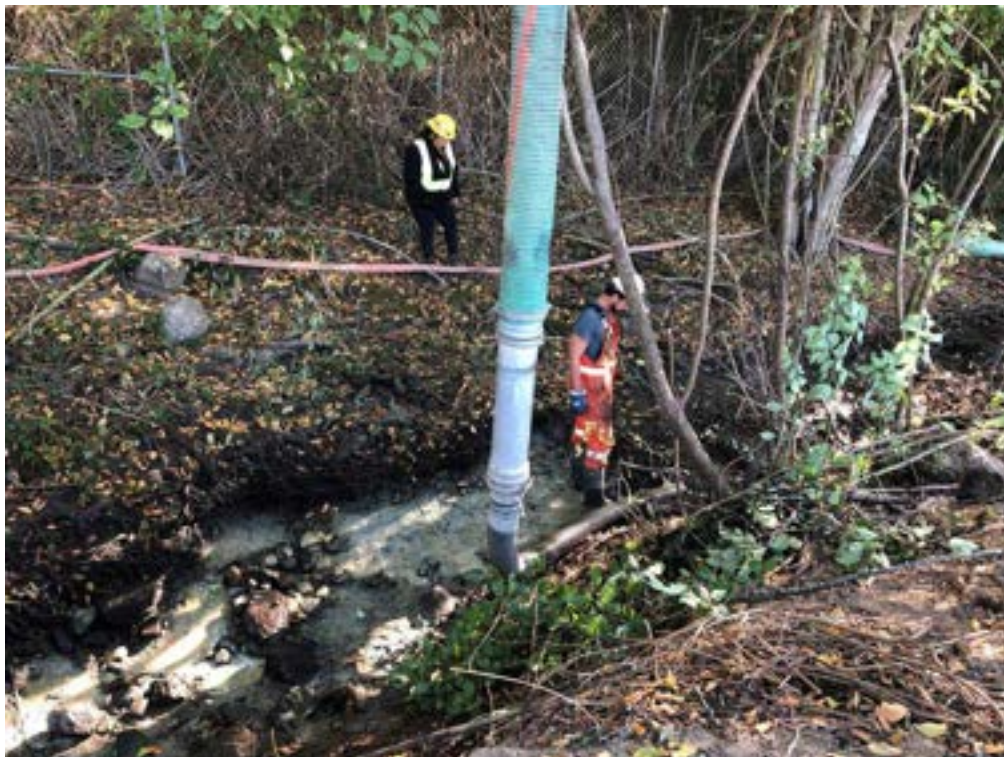
**Photo 14:** Hydrovac excavation in Reach 1C, Tseycum First Nation archaeological monitor can be seen overseeing the excavation.

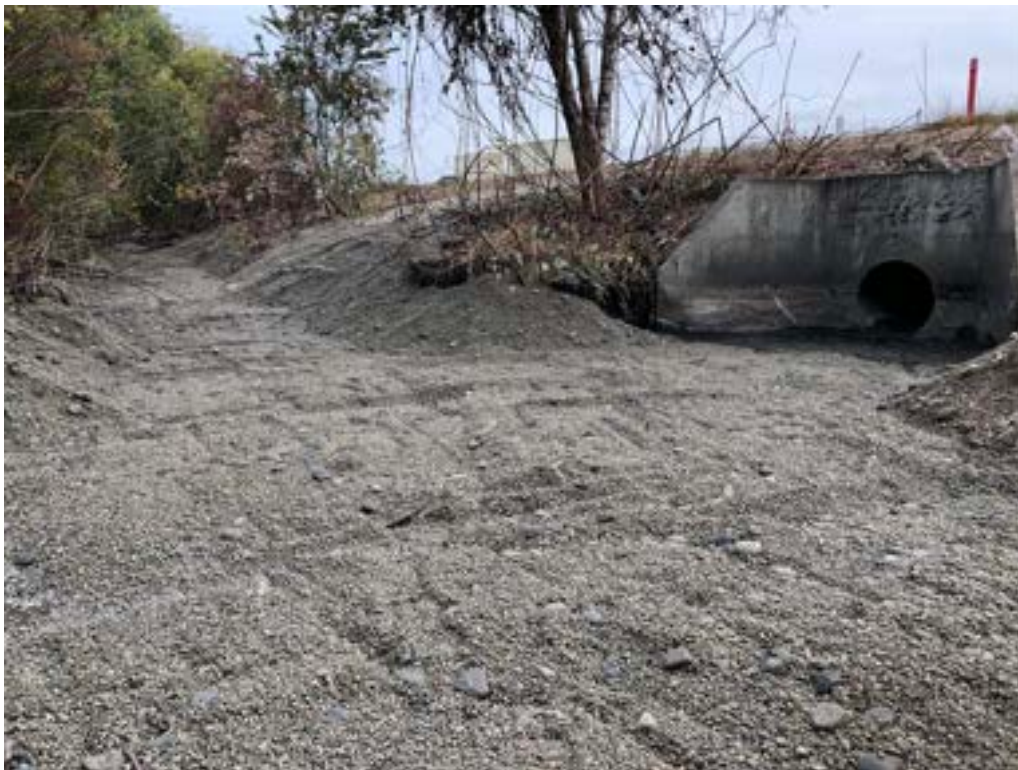
Excavated areas within the creek base were backfilled to pre-excavation elevations using imported materials (Photos 18 and 19). Side slopes along the creek segments were graded to an approximate 2 Horizontal to 1 Vertical (2H:1V) slope. The specified backfill material was used along the channel bottoms to provide substrates suitable for fish and aquatic organisms. The backfill was clean, round, well graded granular material from naturally formed deposits of sand, gravel and cobbles, and free of any recycled material.

**Photo 18:** View of backfill (Type 1 blend) shaping and placement in Reach 1A.

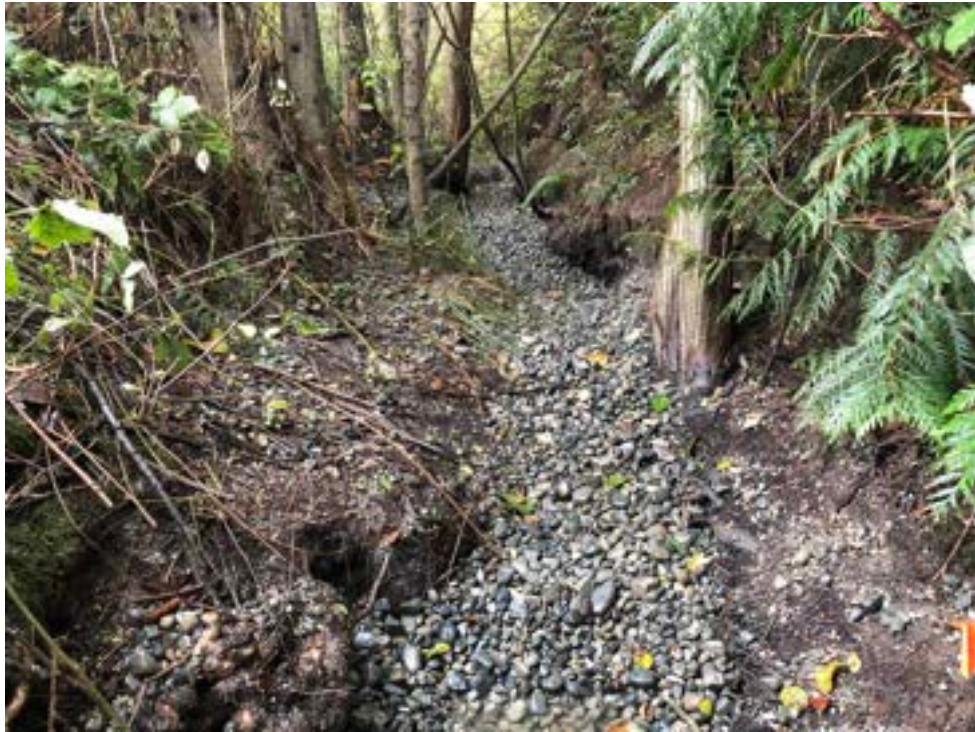
**Photo 19:** View of backfill (Type 2 blend) shaping and placement in Reach 3.

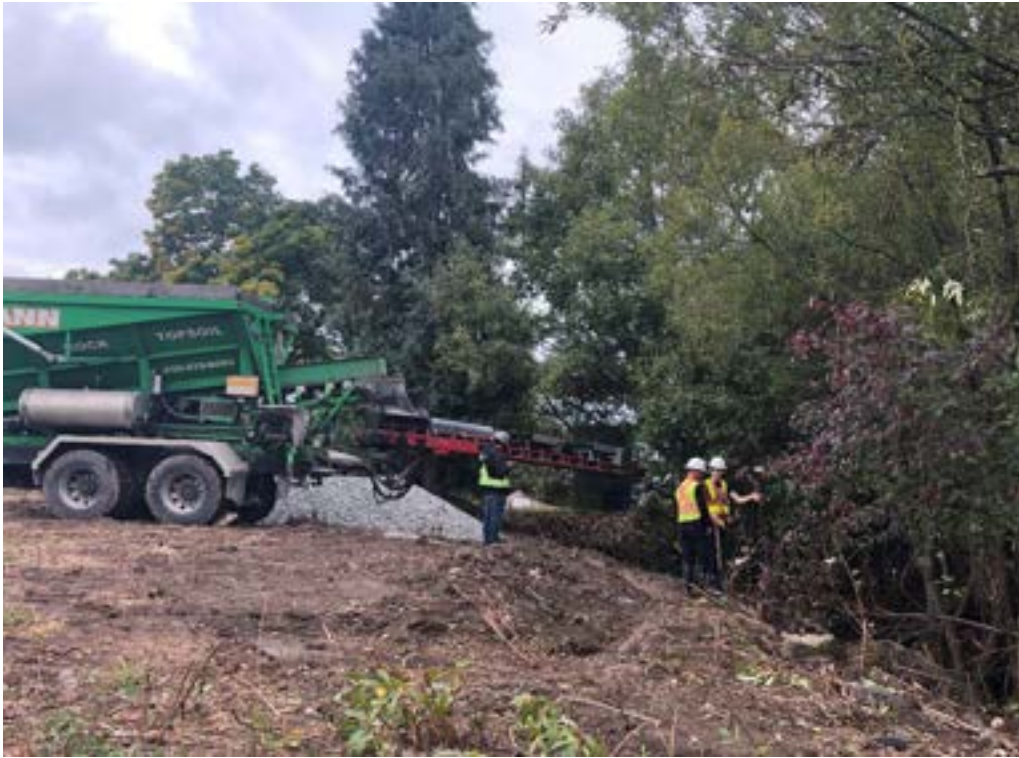
**Photo 21:** Slinger truck placing backfill in Reach 1C where excavator access was limited.

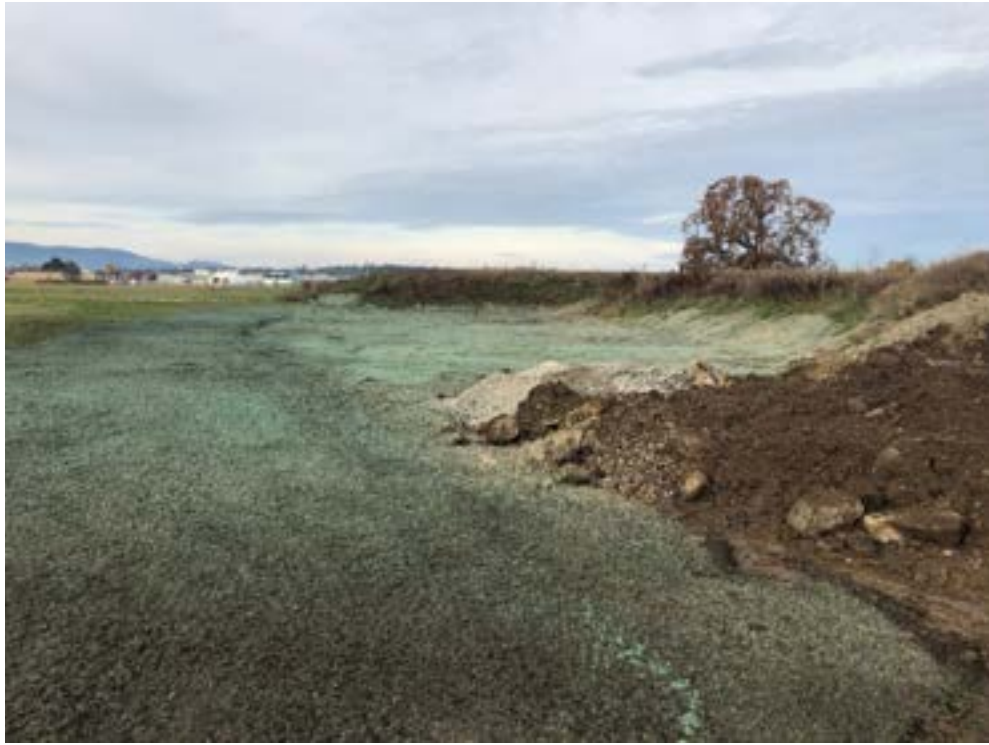
After stockpile removal, a small amount of material remained on the eastern side of the SMA (Photo 25). This material did not originate from the current program and will be addressed by VAA separately.

**Photo 25:** View looking west at the stockpile management area after stockpile removal, remaining VAA material is seen on the right.

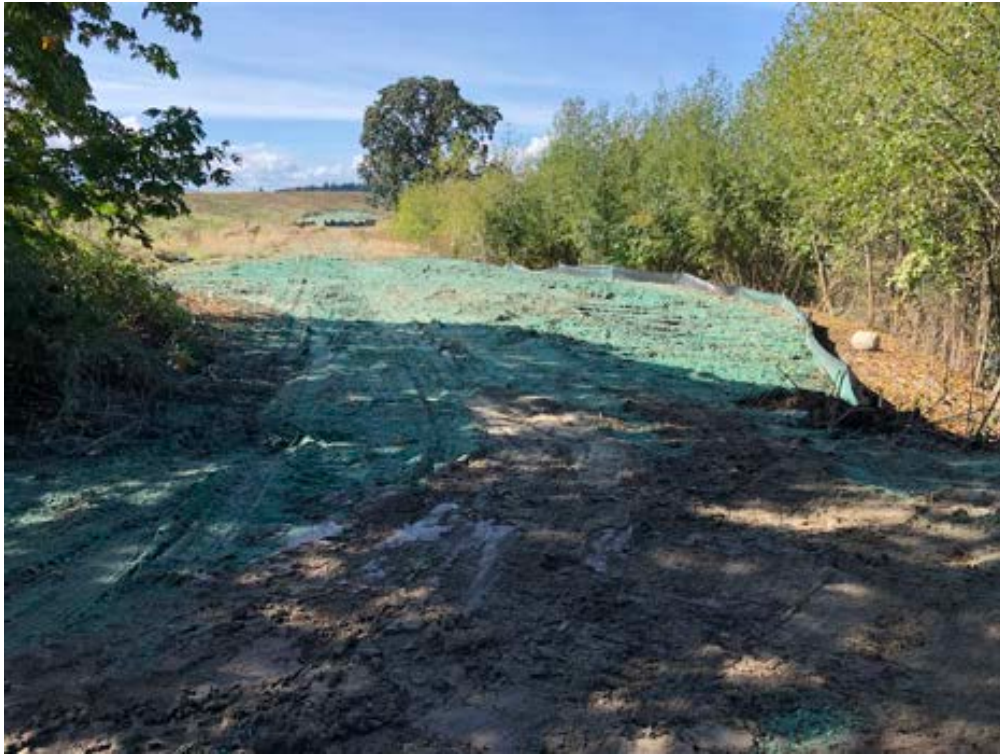
Following levelling and grading activities, a grass seed blend was hydroseeded over the disturbed areas. Silt fences were installed adjacent to channels where vegetation had been removed to provide additional sedimentation and erosion control (Photo 27).

**Photo 27:** View looking west at the southern side of upper Reach 1C post-hydroseed and silt fence installation.

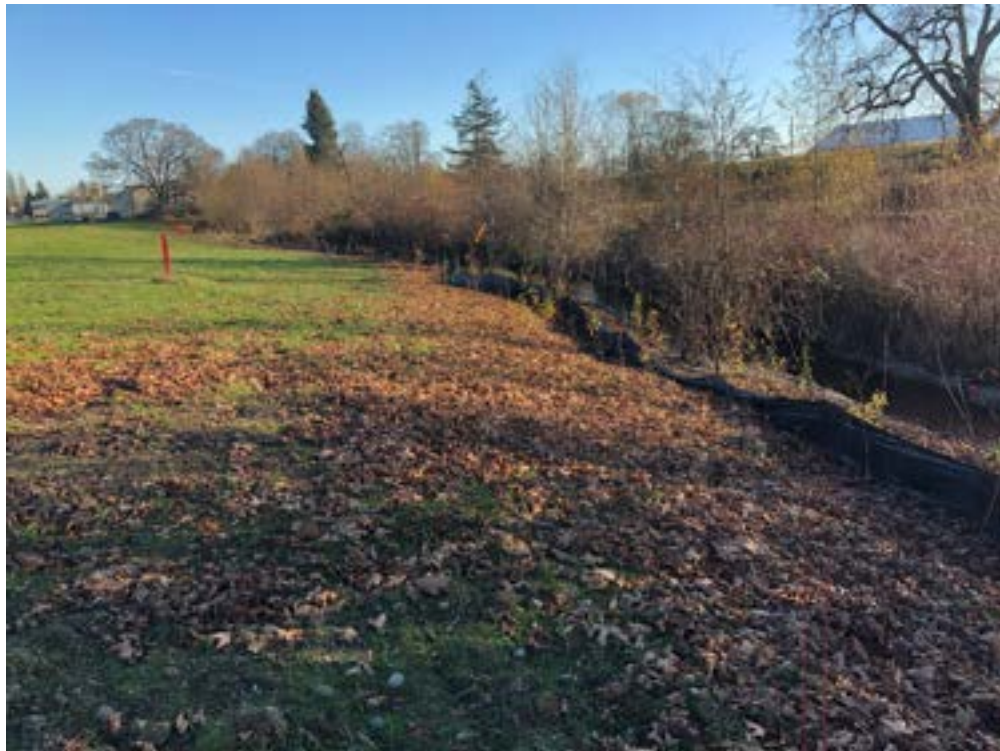
Reach 1A: Revegetation occurred on both sides of the silt fencing (Photo 28) and included all species mentioned above, with the exception of trembling aspen and western sword fern.

**Photo 28:** View looking east at plantings and leaf mulch installed along the north bank of Reach 1A.

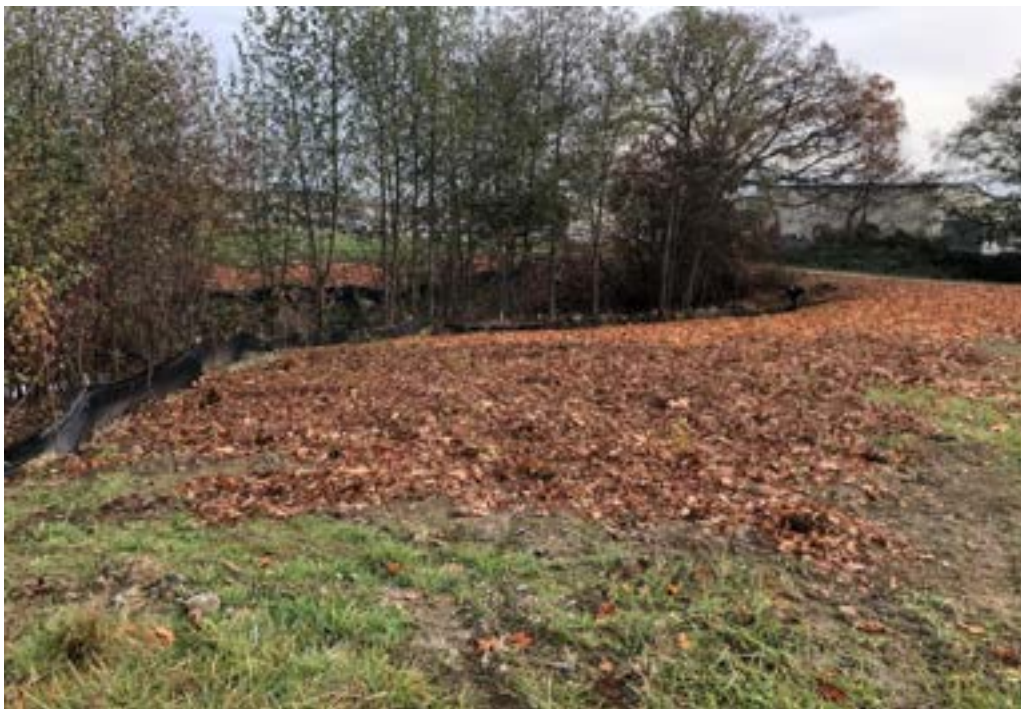
Reach 1C: Dense plantings of nootka rose and thimbleberry were installed where Himalayan blackberry removal occurred (Photo 30). Along lower Reach 1C, western sword fern was planted along the stream edge and bank (Photo 26). Other species such as red alder, red osier dogwood, red elderberry, nootka rose, thimbleberry, common snowberry and pacific ninebark were selected for planting along Reach 1C.

**Photo 30:** View looking northeast at riparian planting along upper Reach 1C, where Himalayan blackberry removal occurred.
